Kitchen
Eastern Shore State Hospital
Dorchester County, Maryland
Survey No. D-714

**MESS HALL BUILDING (KITCHEN)
EASTERN SHORE STATE HOSPITAL**

Survey No. D-714

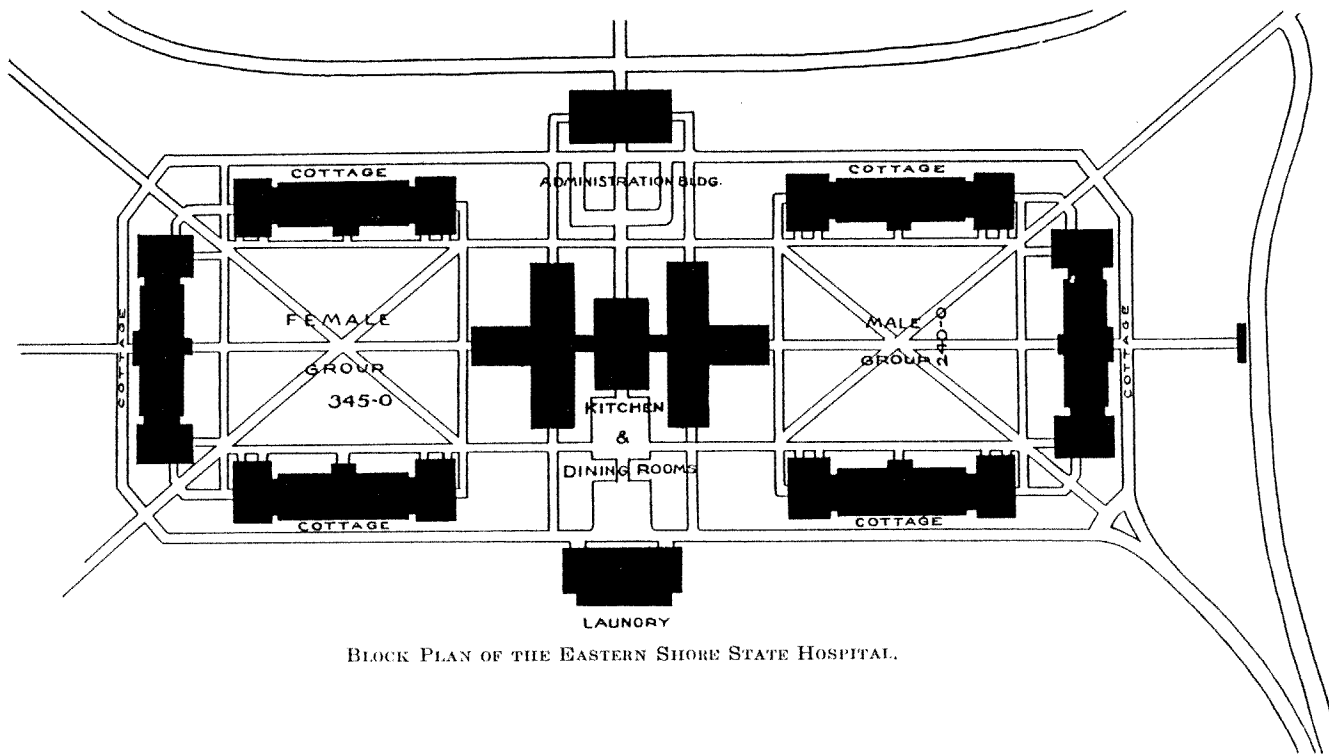
BLOCK PLAN OF THE EASTERN SHORE STATE HOSPITAL.

"Block Plan of the Eastern Shore State Hospital" (Source: Eastern Shore State Hospital, Biennial Report 1913-15, p. 15)

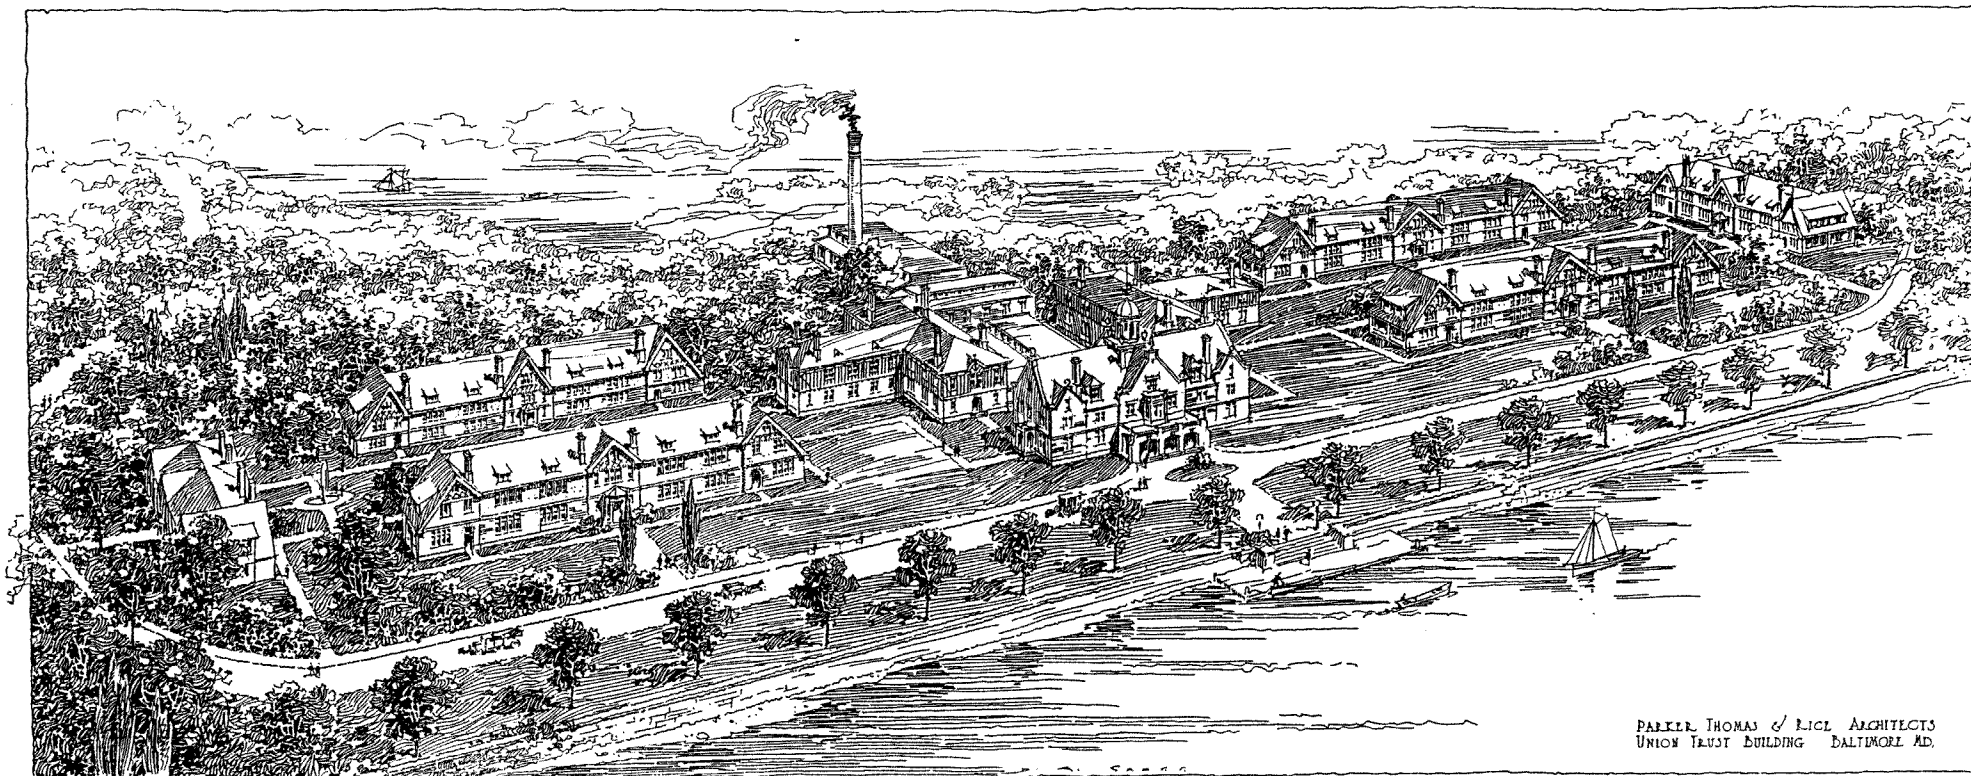
EASTERN SHORE STATE HOSPITAL
SHOWING COMPLETED GROUP AS CONTEMPLATED.

"Eastern Shore State Hospital Showing Completed Group as Contemplated" (Source: Eastern Shore State Hospital Biennial Report, 1913-15, frontispiece)

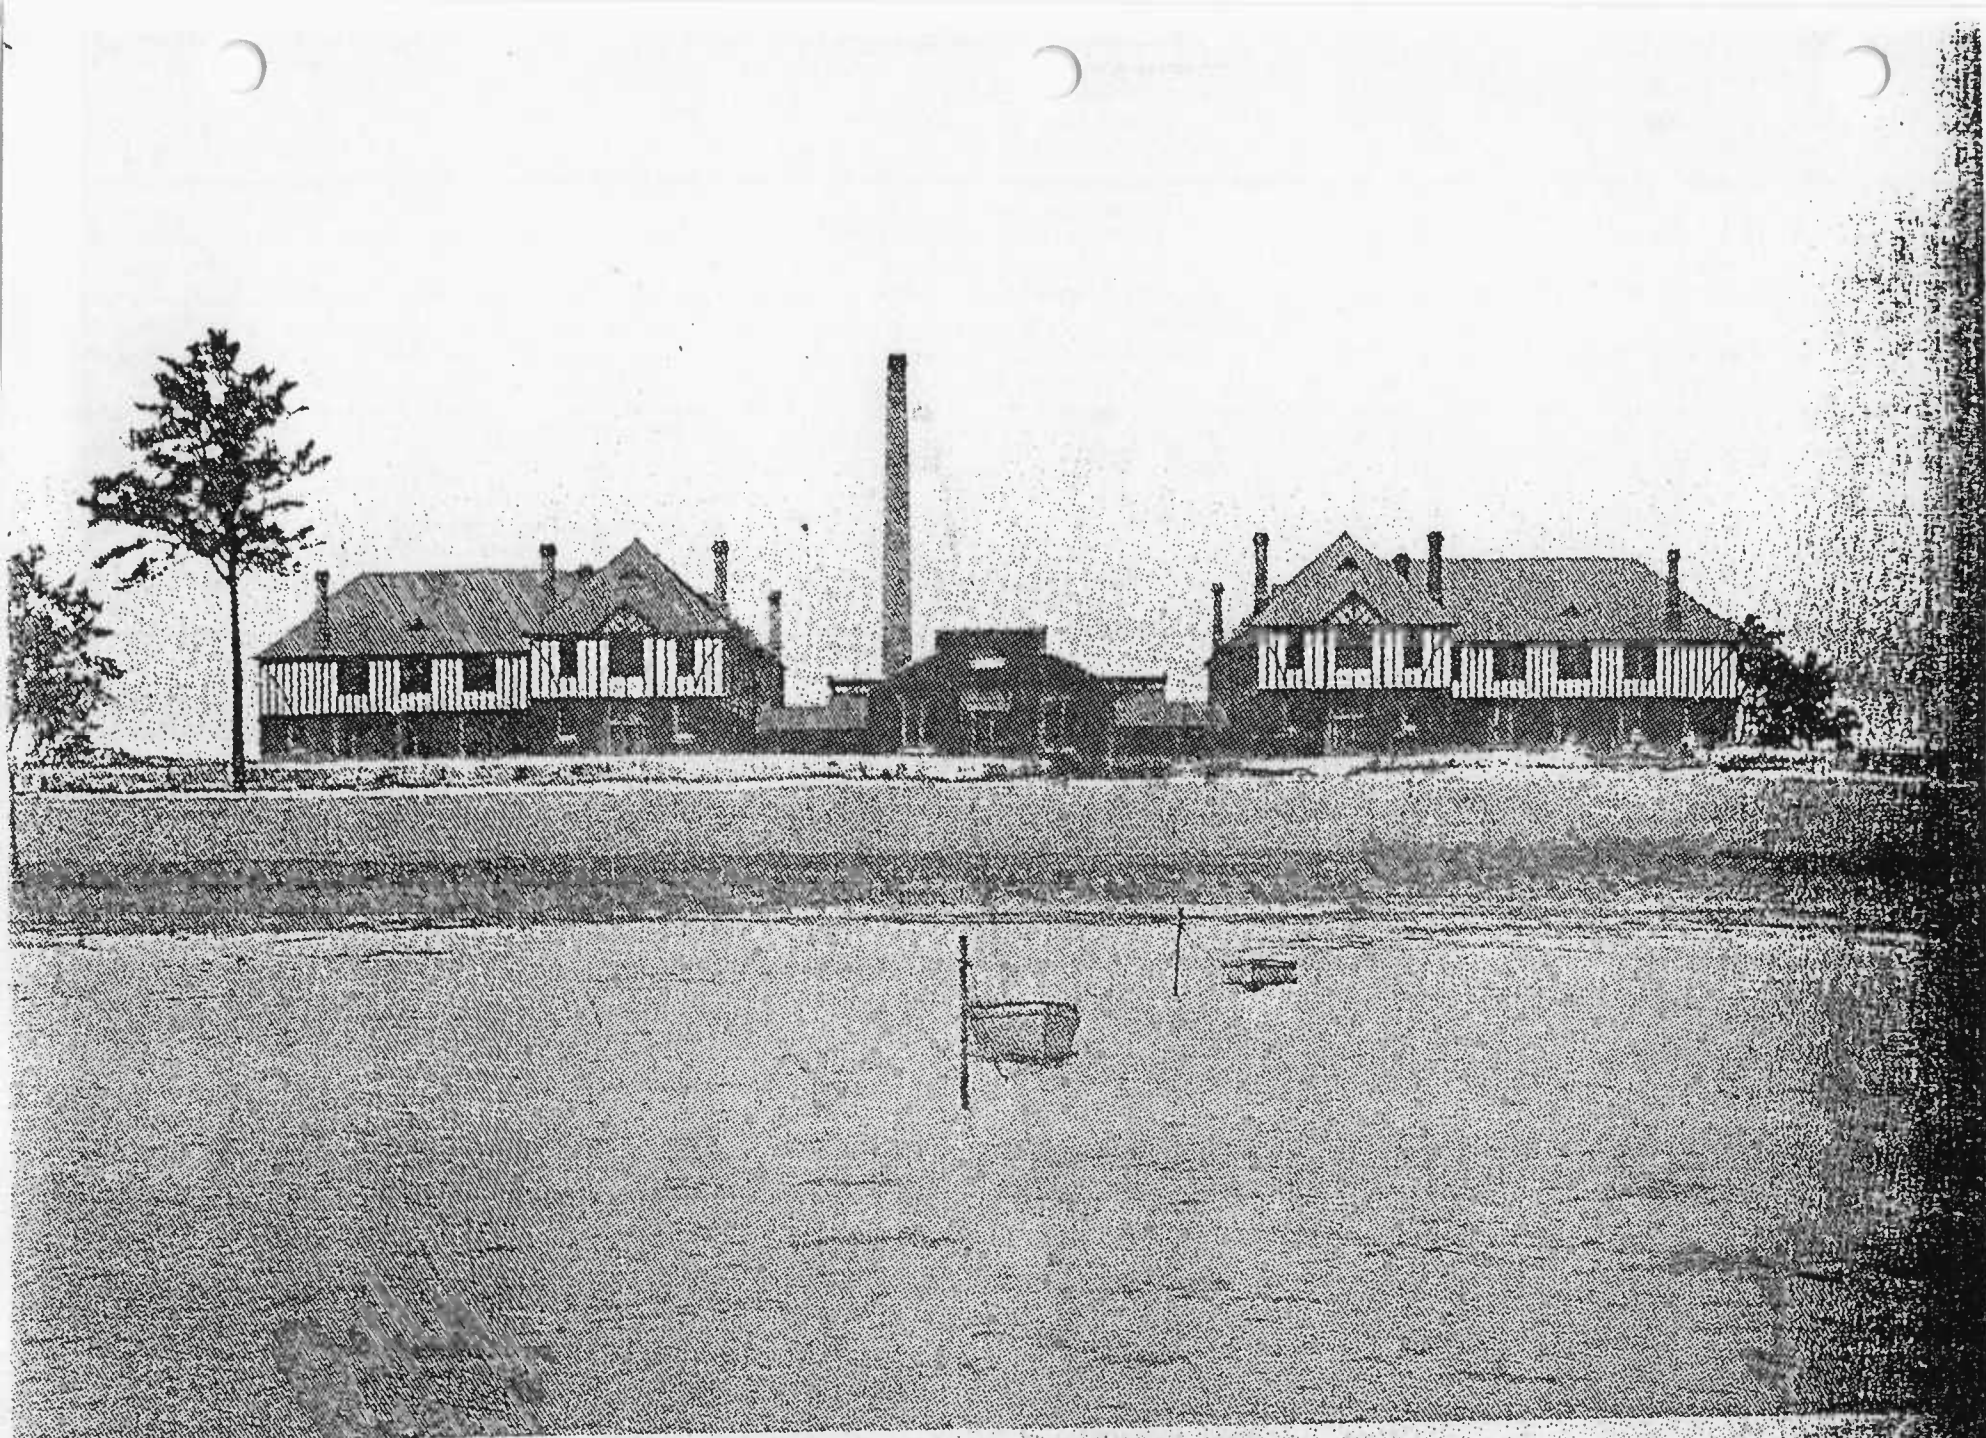
STATE HOSPITAL FROM WATER FRONT, CAMBRIDGE, MD.

"State Hospital from Waterfront, Cambridge, Maryland" (Source: Postcard, Eastern Shore Hospital Center Archives)

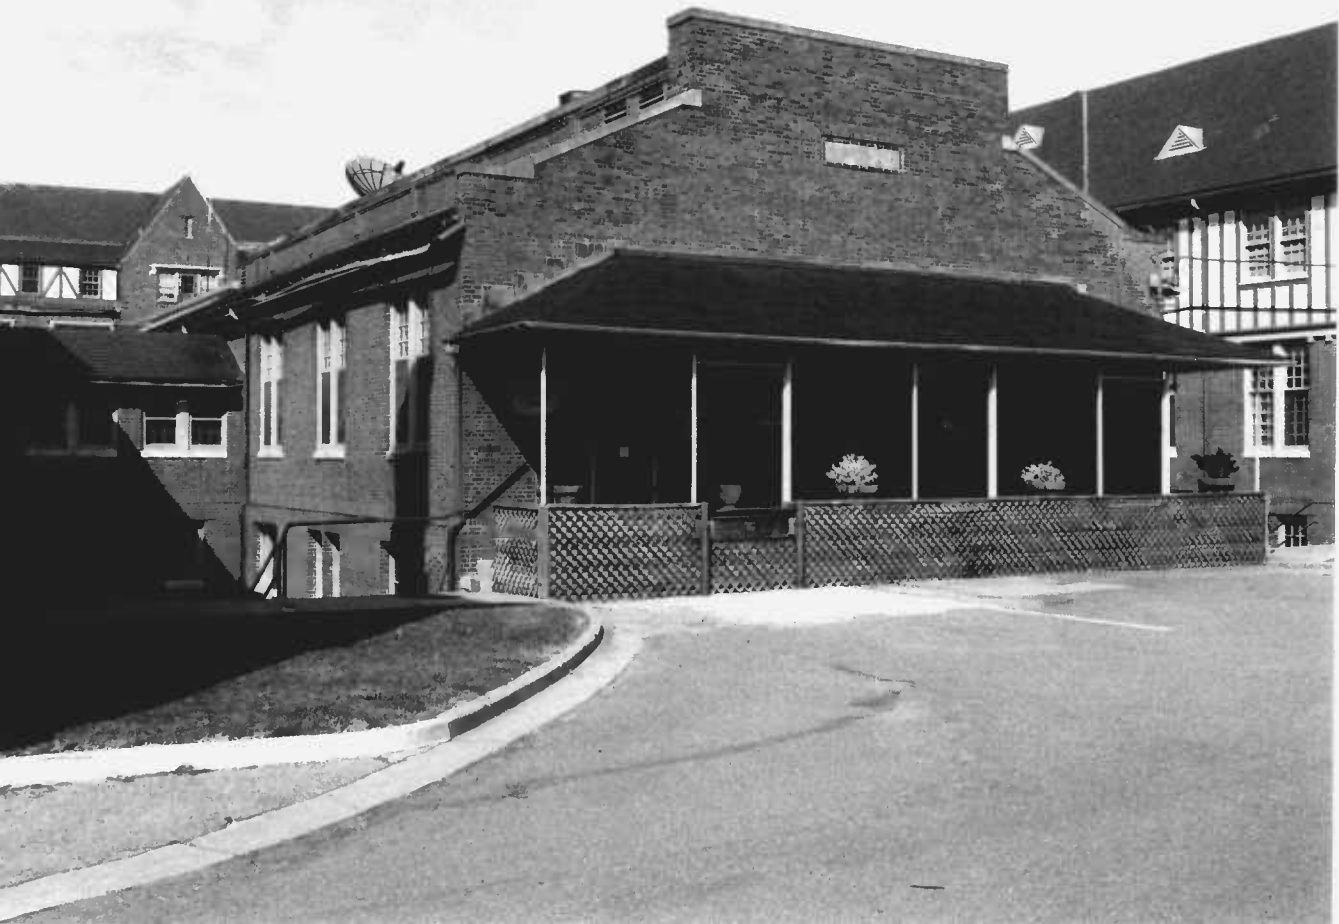
1 OF 8

VIEW FROM SW

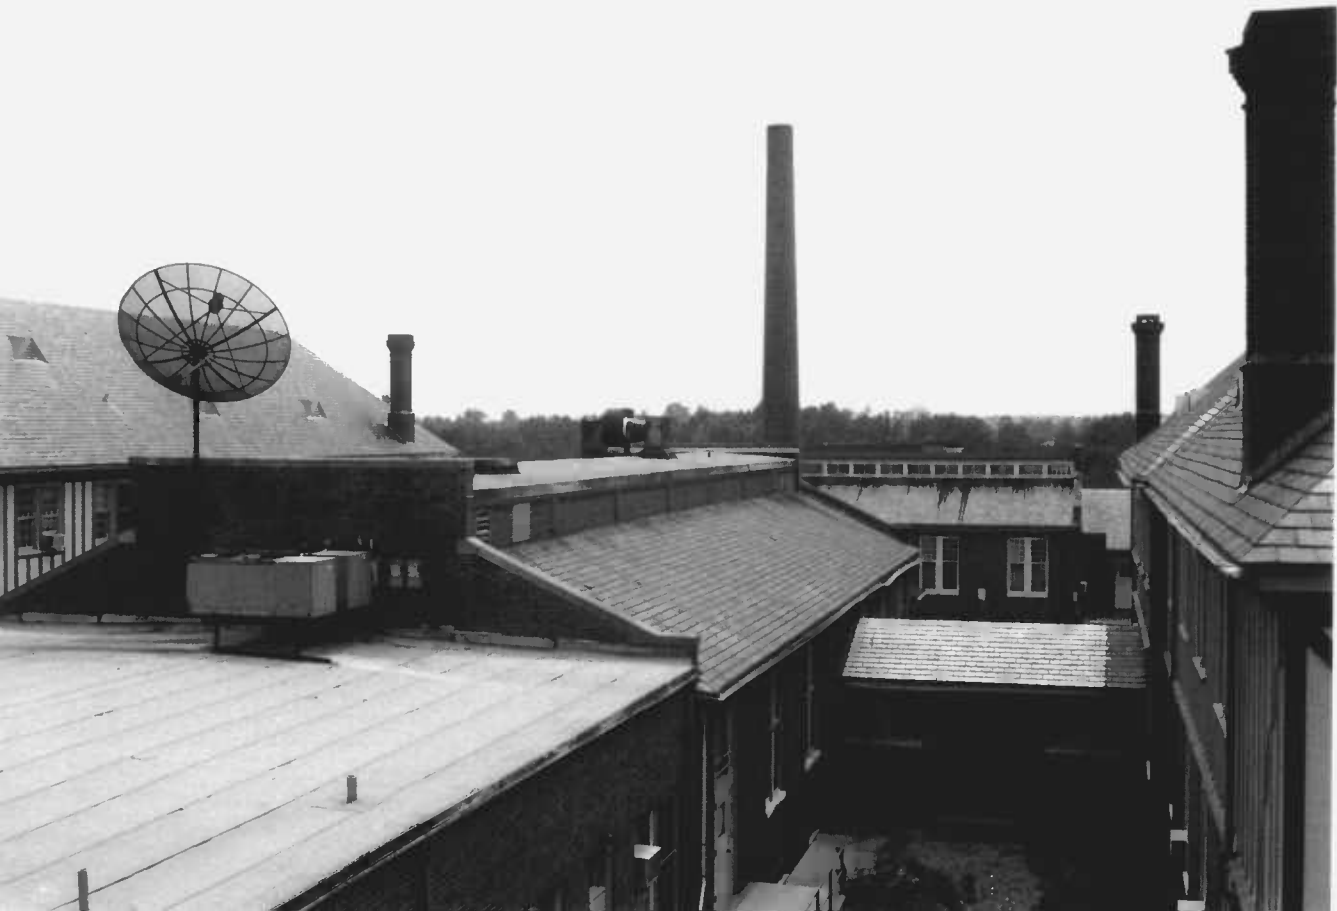
2 OF 8

VIEW FROM NW

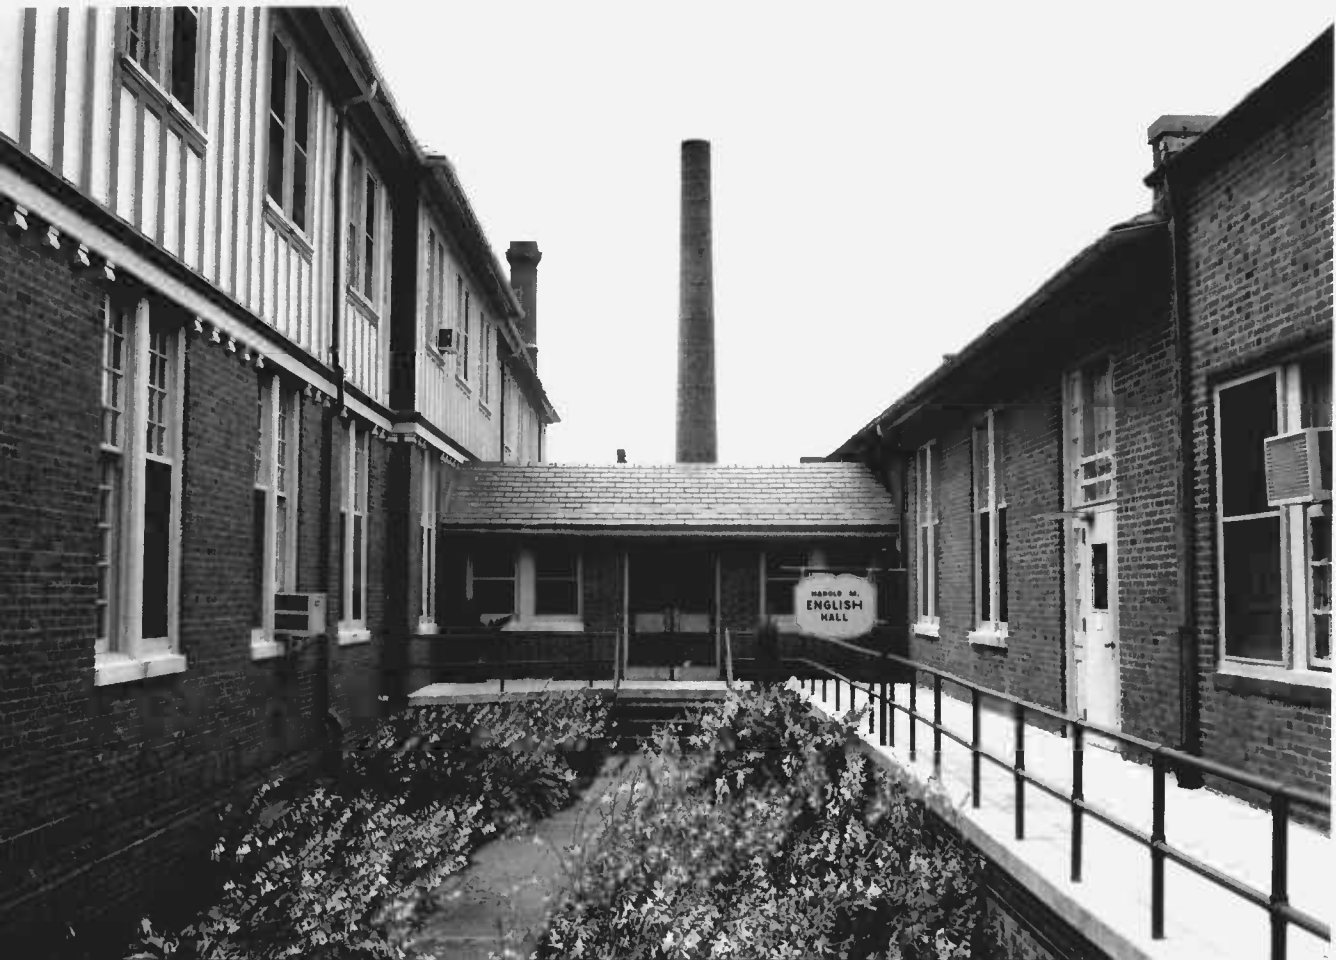
3 OF 8

The kitchen has been extensively altered over the years. In 1940, Henry Powell Hopkins added a one-story brick addition connecting the Administration Building (Survey No. D-715) with the south wall of the kitchen. While the distinctive profile of the gable roof is still visible, the addition obscures the original north wall. On the south, only the west door opening remains; the other two openings have been infilled with brick. Lattice work obscures the original loading dock and a recent porch obscures the lower half of the facade. The monitor has been bricked in. The hyphens, which have been infilled with bathrooms, have lost the transparency shown in historic photographs.

EAST HYPHEN + E FACADE FROM N

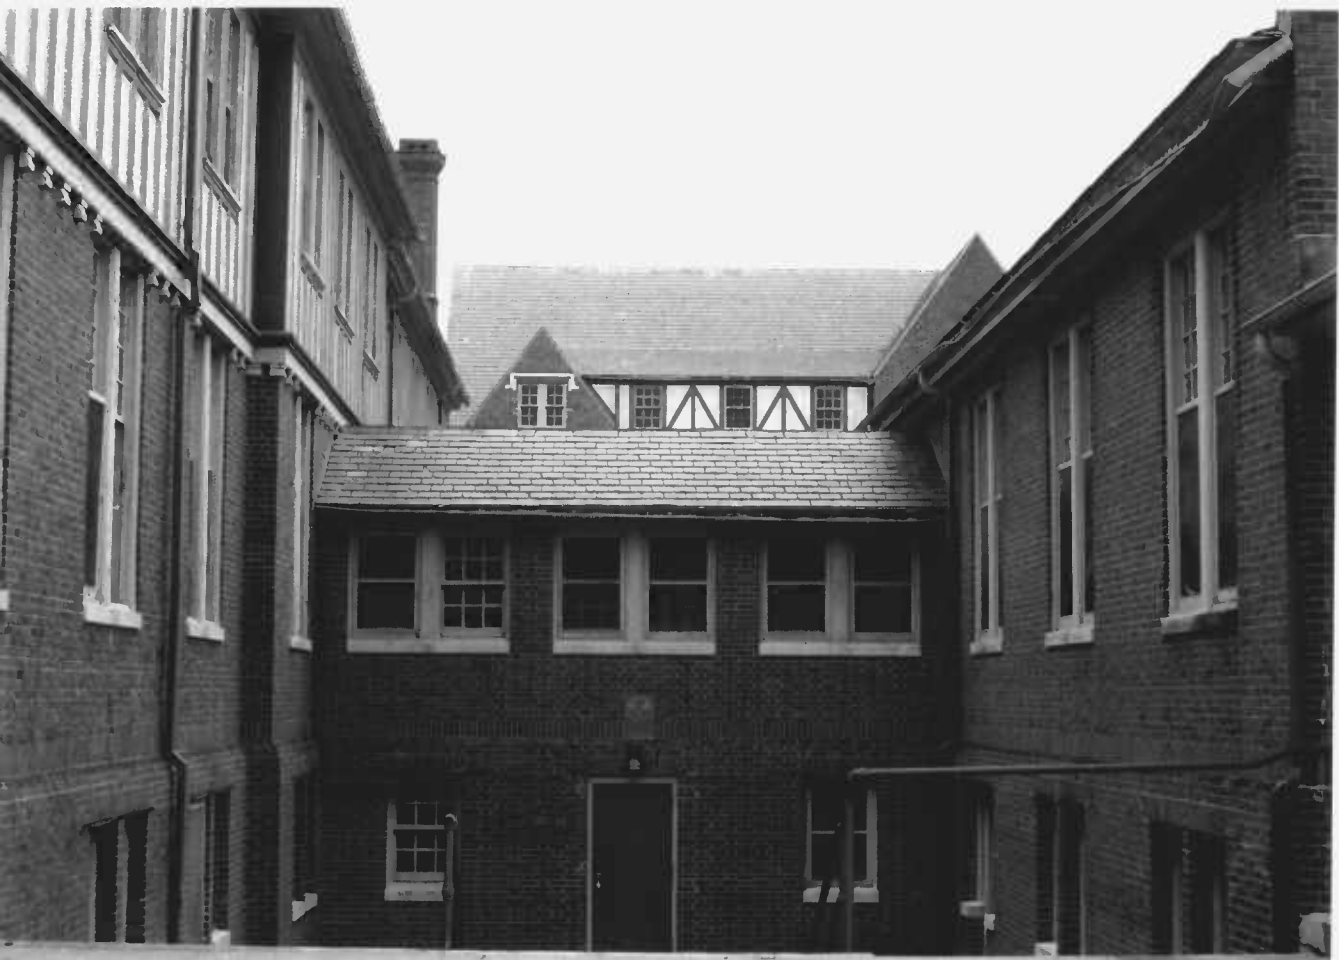
WEST HYPHEN + W FACADE FROM S
W OF 8

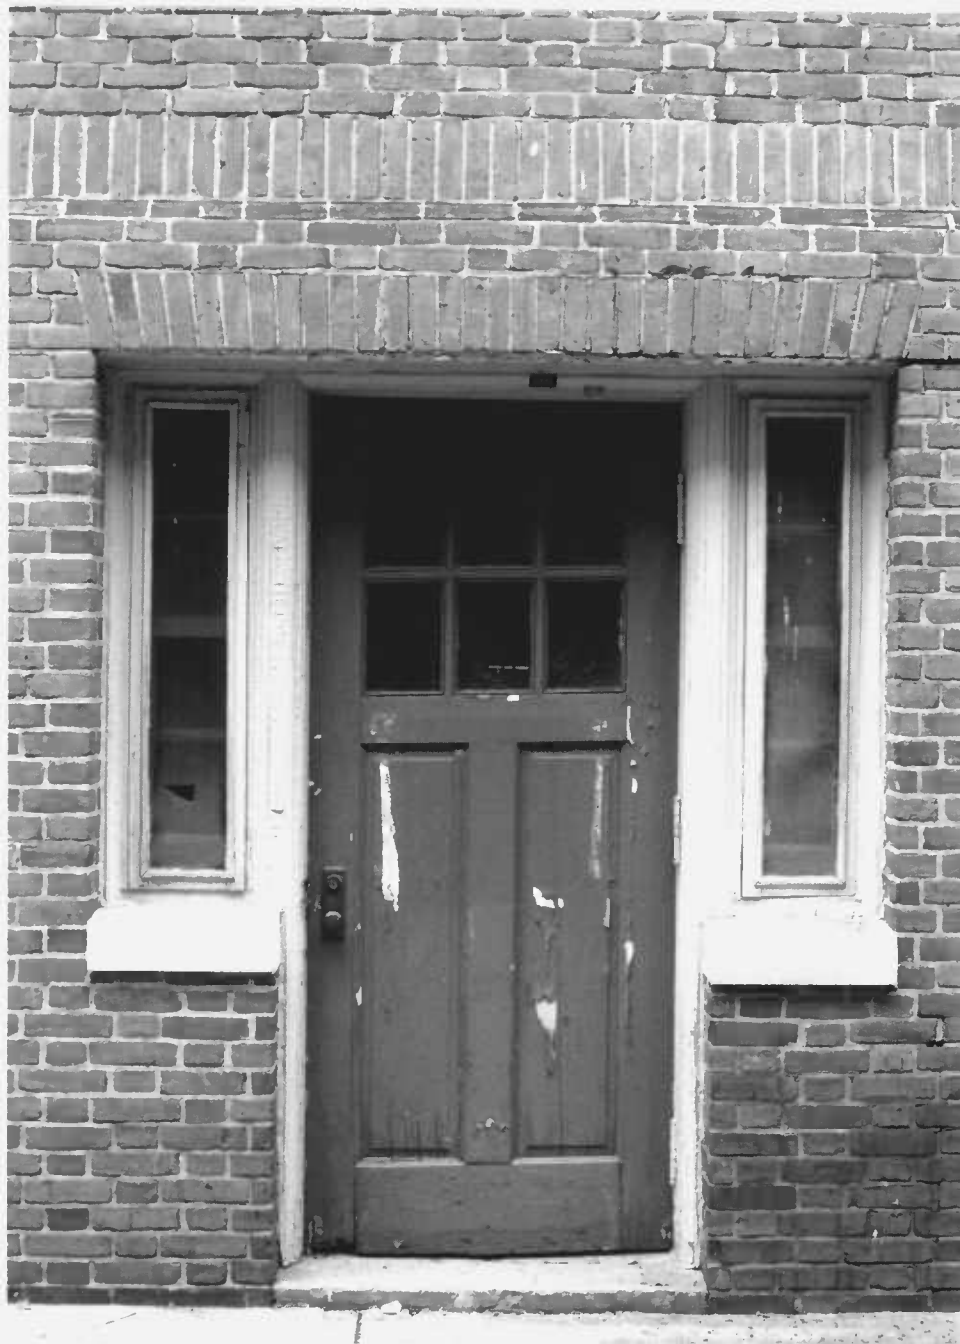
S OF 8

The exterior of the Kitchen is executed in Flemish bond brick with randomly glazed headers. The basement is treated as a watertable with a molded shoulder course below a soldier course that forms the base of the wall surface. There are secondary entrances to the basement, which is approximately 9 ft. high, situated at the center of the east and west facades south of the hyphens. The basement entrance on the east retains its original door, a two-panel wood door with four-light glazing. Paired window openings on the east and west facades are placed above sandstone sills. The south and north walls rise to parapeted stepped gables. A Peach Bottom slate roof with a monitor (now infilled) runs between the gables. Because of the change in grade, the hyphens, which connected the Kitchen to the central serving rooms for Unit I and Unit II, have two full stories on the south and one story on the north. The hyphens, which are glazed with paired multiple pane double-hung sash at the 1st floor, incorporate the watertable and Flemish bond brick found in Unit I and Unit II. The hyphens are topped with a slate gable roof that runs below the eave of the Kitchen and the 2nd floors of Units I and II. On the south, the hyphens have a single door flanked by small single windows at the basement level and three sets of paired windows at the 1st floor level. On the north, there are double doors flanked by paired windows.

BASEMENT DOOR, E FACADE

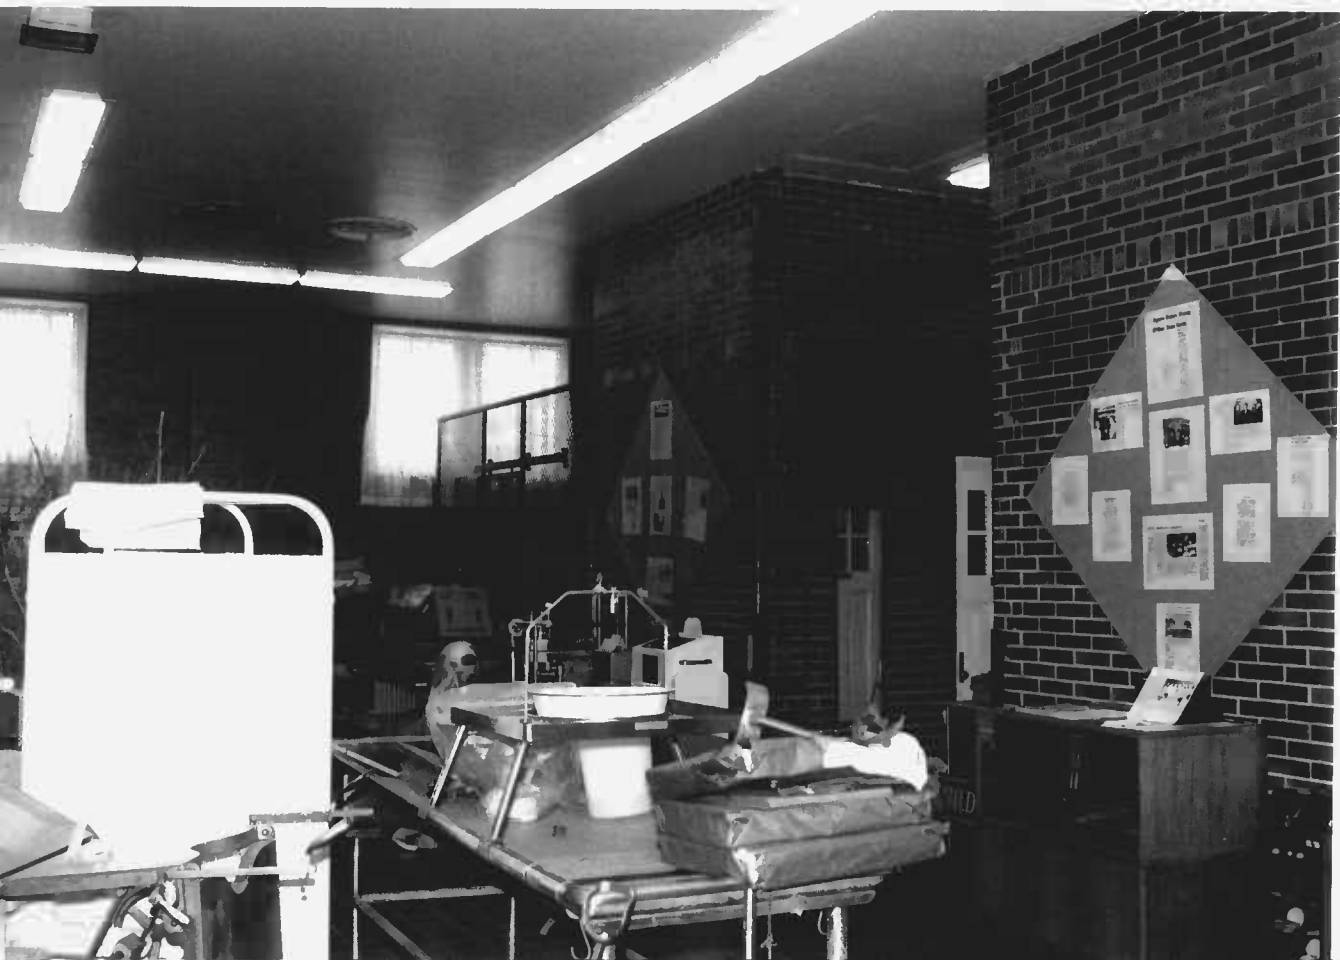
6 OF 8

The interior has been more drastically changed than the exterior. While the demising wall in line with the south wall of the hyphen remains, most of the interior masonry partitions have been removed and the spiral stair has been taken out. The cooking area, which became the Polynesian Dining Room and is presently a conference facility, has been completely altered. Ceilings have been dropped and wall and floor surfaces covered with contemporary material. The southern half of the kitchen, presently used as a museum, is somewhat more intact and retains its original finishes. Original salt glazed brick walls are still visible in the now open-plan space. The original restrooms still remain in this area. It is not known whether the floor tile is original or whether it is replacement tile dating to the mid-1920s. Around 1925 the original concrete floor under the cooking equipment in the kitchen was replaced with tile.¹

S END OF 1ST FLOOR FROM NW

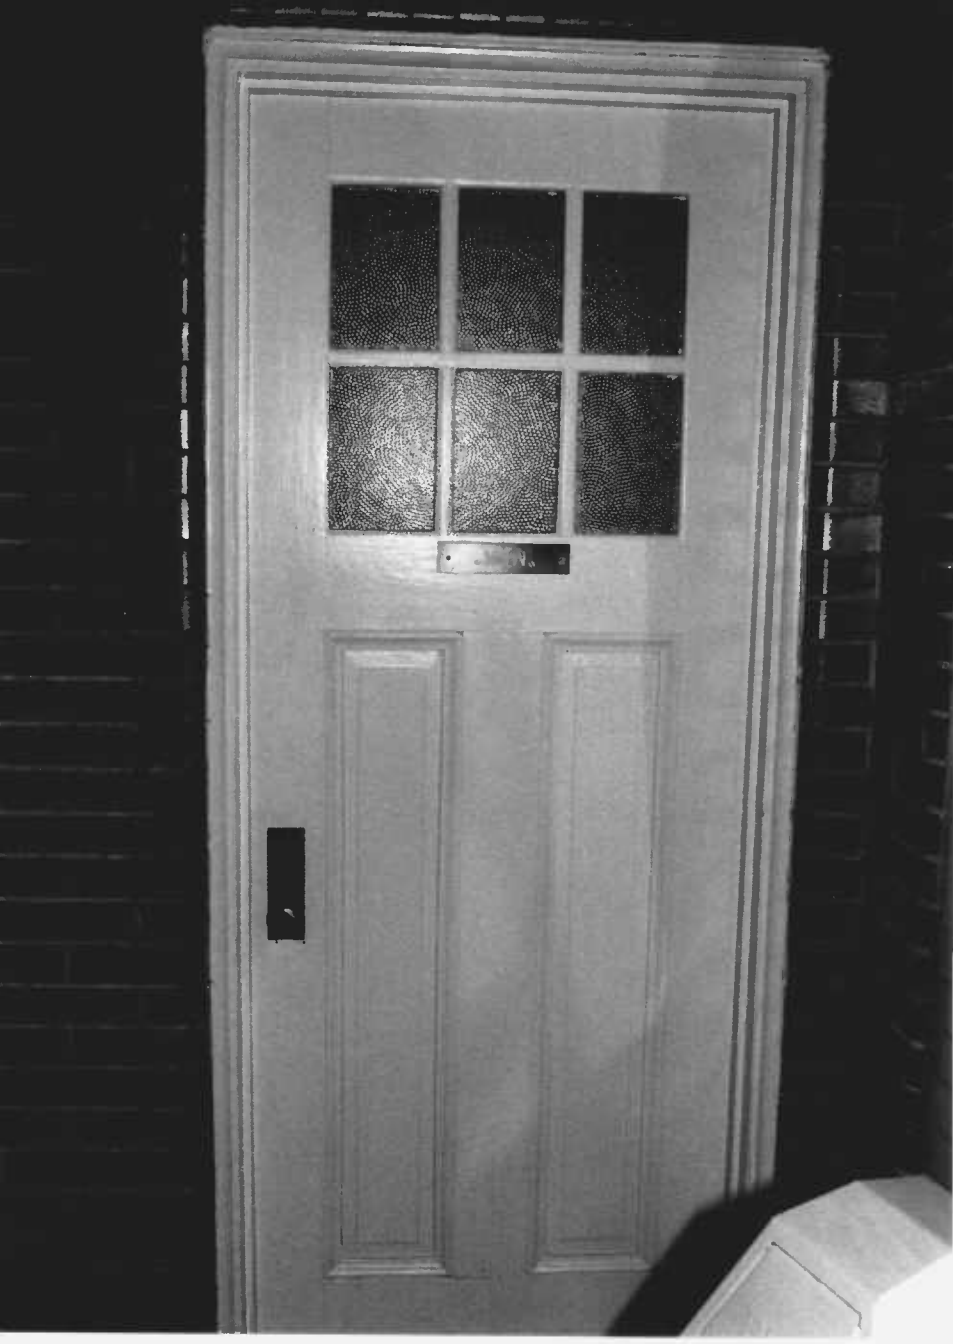
7 OF 8

1ST FLOOR BATHROOM DOOR

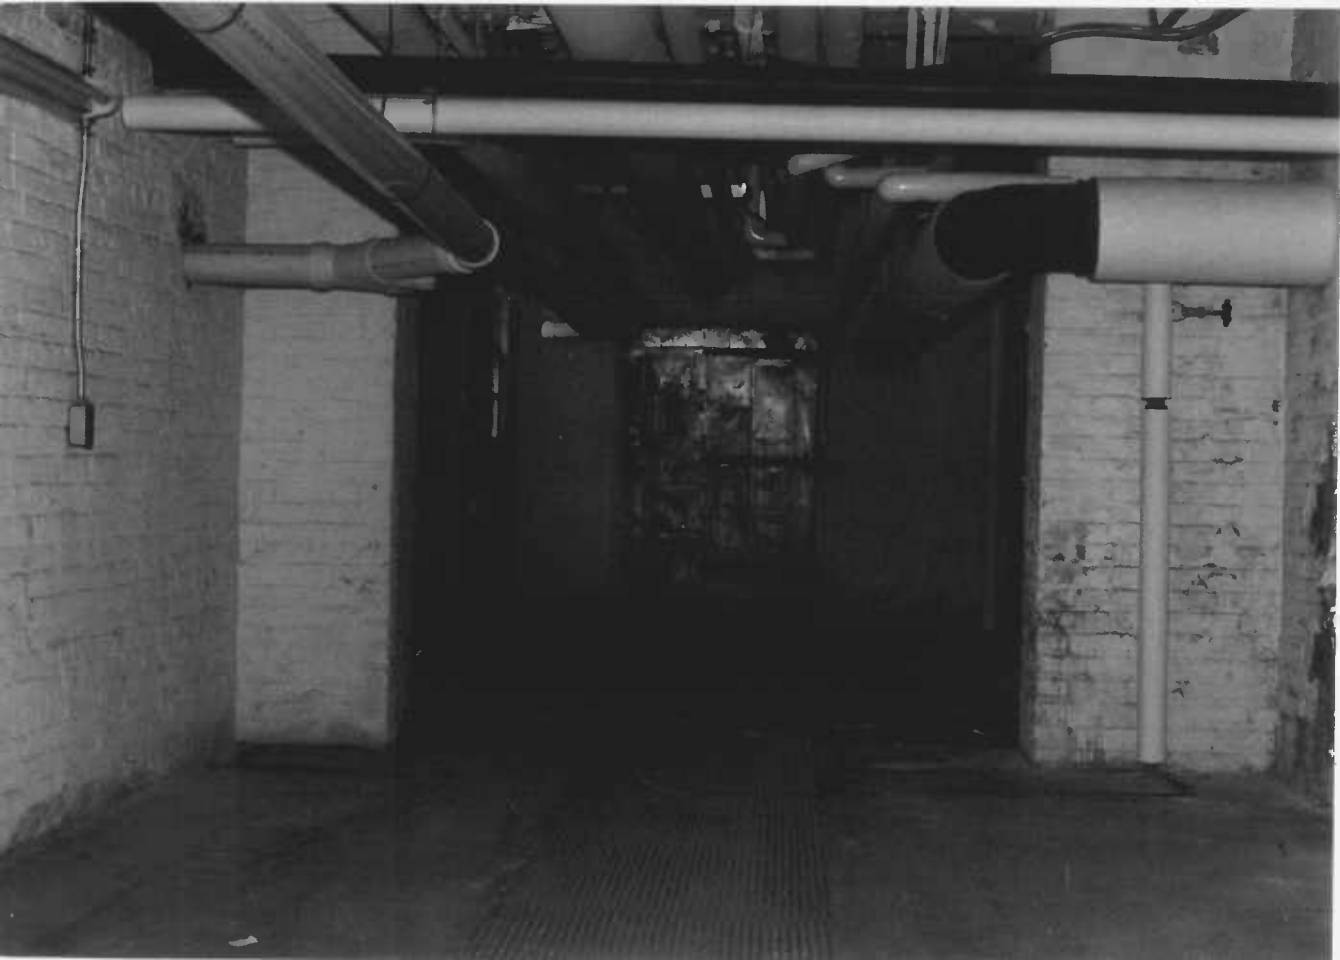
8 OF 8

BASEMENT TUNNEL
